SILVER SPRINGS SINGLE FAMILY SUBDIVISION - SEGMENT A 17 MAN HOLES

Report Compiled by Clay and Lucy Archer, contributions by Bradley Hornsby 5/26/2020

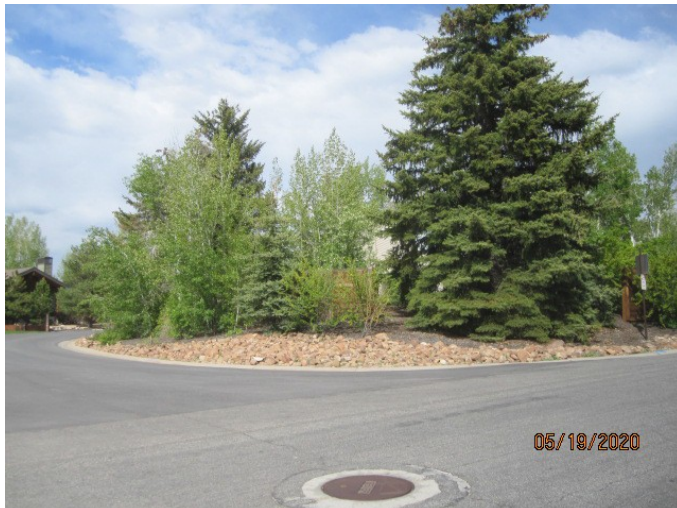
Mh 1A Lot 16 at corner of Silver Springs Drive and Meadows Connection. Robertshaw. Alliance Engineering Map Report: "Found steel lid in landscape rocks at 13" depth "at center of curve of the two streets. 7.1 feet behind gutter; 44 feet from sewer manhole; 53.7 feet from street sign. " Direct measurement with surveyor chain. No inflow, unless via perforated tubes

6' to 10' underground. Planned out flow is diagonally under and across Meadows Connection to Lot 17 Manhole 13A.

Owner has covered curve easement with red rocks. The Alliance Engineering Map shows a gap between the location of Mh 1A and the beginning of the underdrain line to Mh 2A. We don't know whether it is a drafting error or whether the line between 1A and 2A in ground-truth are indeed not joined to each other.

Buried under berm and rocks. **Inactive.**

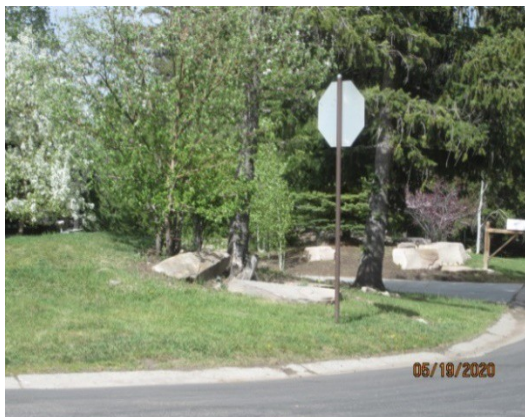
Mh 2A Lot 1 at corner of East Meadows Dr. and Silver Springs Drive. Clark-Oberholtzer-Villano. Alliance Engineering: "Did not find manhole. Strong metal detector signal at excavated depth of 18". 5.4 feet behind gutter. 11.7 feet from Stop sign." Buried under berm. If there is any inflow, it would be via perforated tubes 6' to 10' underground. **Inactive.**

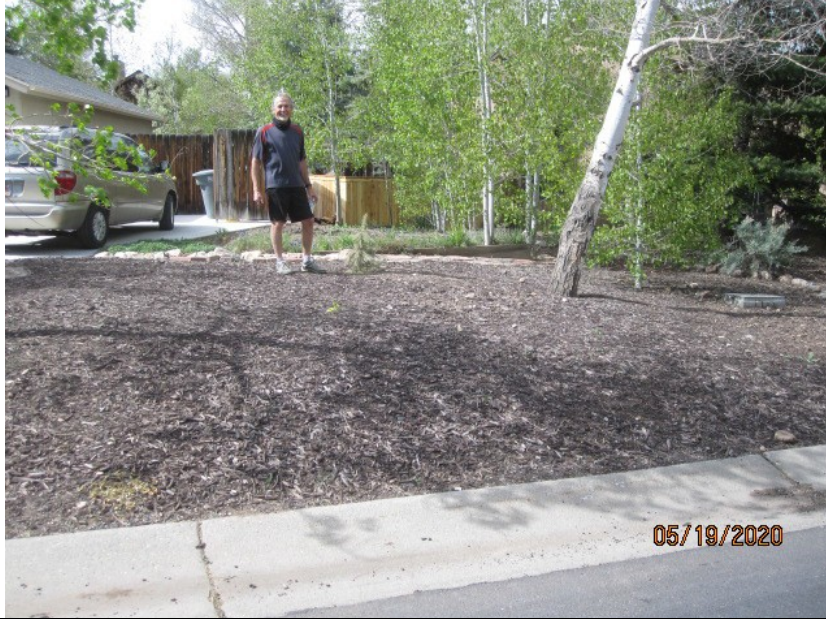
Mh 3A Lot 4 on 4841 East Meadows Drive. Mailbox 25.1 ft. 21.5 ft from sewer manhole. Owner since 1992, Paskoski, told us the mh 3A lid is directly in front of where he is standing 12' behind the gutter, and east of his driveway. The steel lid has a large cable over the top of the lid. He will be adding landscaping in this area again. Buried under this berm. Dry unless there is inflow via perforated tubes 6' to 10' underground. **Inactive.**

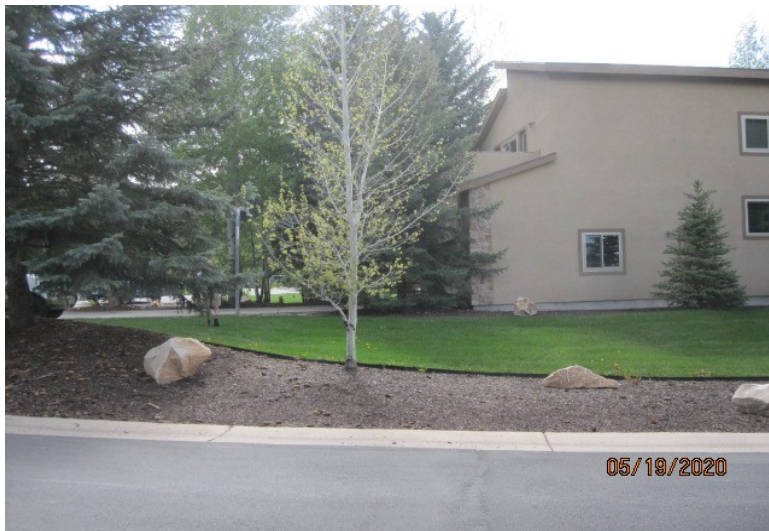
Mh 4A on Lot 26 at the corner of Meadows Connection and East Meadows Drive. Kahn-Brady. Alliance Engineering in 2014 wrote: "Steel lid exposed, 5.8 ft behind gutter. 2014, the lid is buried in landscaping at grade. 14 ft. from street sign." Owner since 1992 has since changed the landscaping, covering the area with chipped bark. A 'lost creek' existed between Lot 26 and 27, as seen on aerial photographs dated 1987 and to 1992, and remembered by neighbors. When the creek was covered did flow energy convert to subterranean activity directed to adjoining lower elevation properties? Lots 28, 29, 54, 55, 56, 57? Manhole 4A is buried under landscaping along this curb. No inflow, other than via perforated tubes 6' to 10' underground. Dry when compared to the minimal collection next door in manhole 11A on Lot 25. **Inactive.**

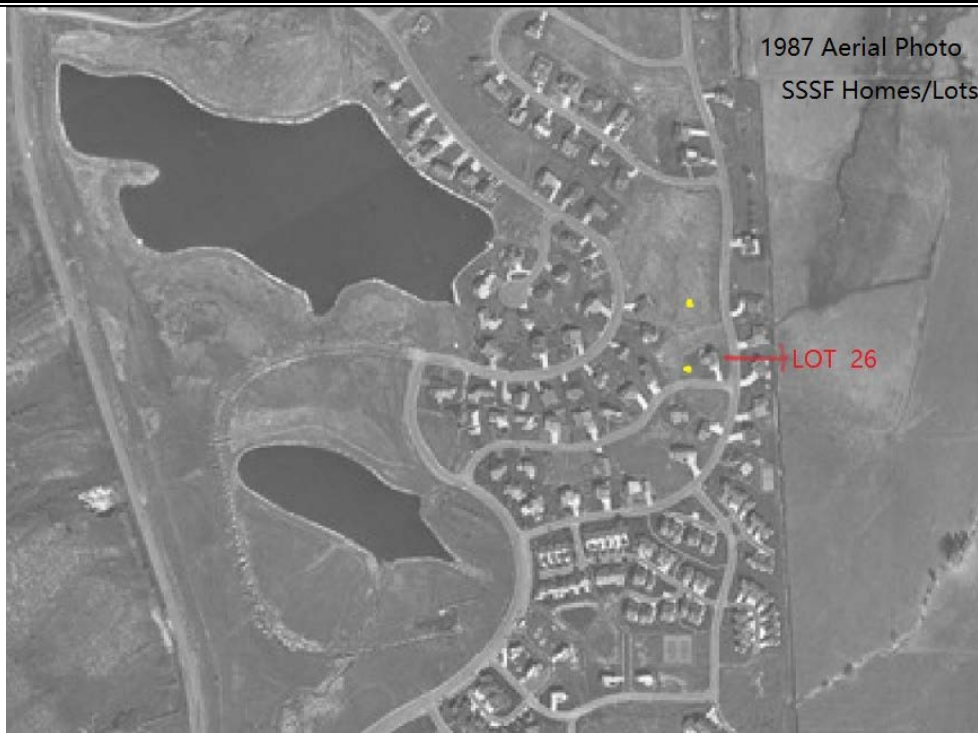
This 1987 Aerial Photograph above shows (between the two yellow dots) a creek existed between Lots 26 and 27. Neighbors remember traversing its small bridge. Just how filling-to-extinction, the small creek on Lot 27, affected subsurface flow is speculation at this point.

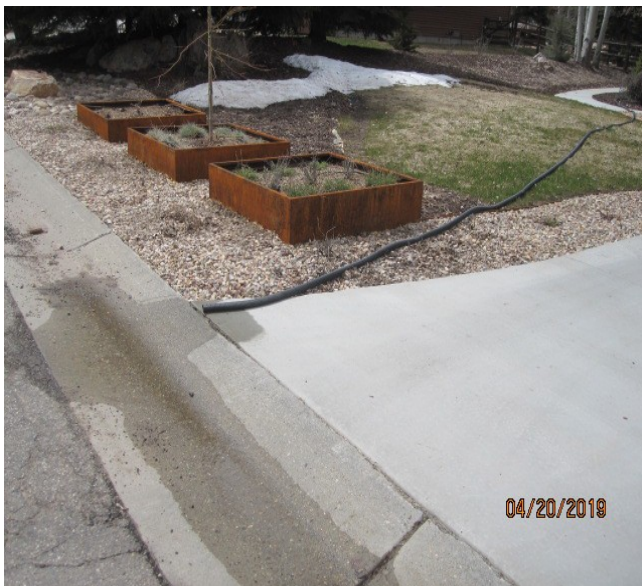
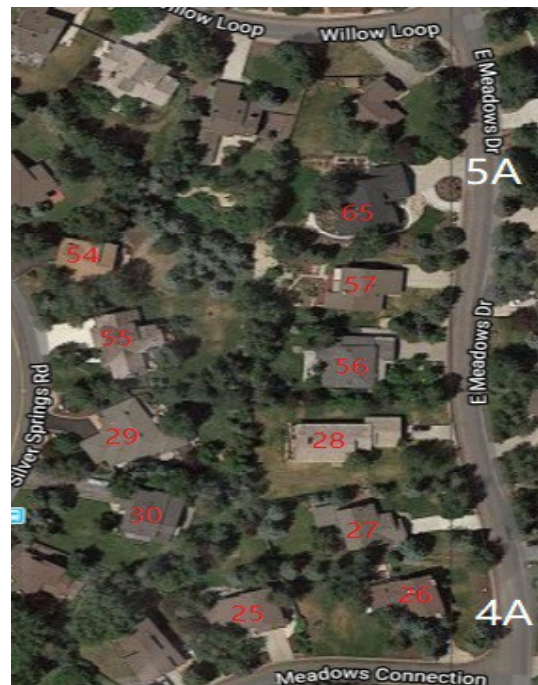
April snowmelt, sump pump hoses from crawspace to curb.

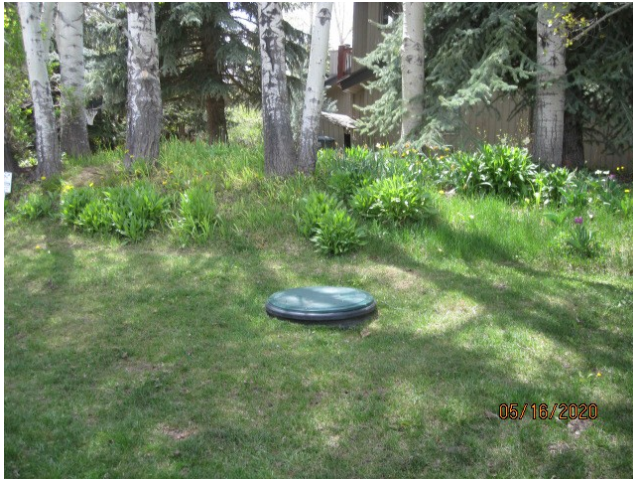
Mh 6A Lot 87. Adelson on East Meadows Drive. This MH has a 2 foot opening with a green plastic cover. The water at this mh was flowing lightly and was at a low level at the inlets and outlet pipes. The inlets to this MH are from 8A and 9A. The outlet is into a diversion PVC pipe to Willow Creek. A ProPipe person operated the Water Jet clearing hose into the inlets and outlets to a distance marked on the HOA's large Underdrain Map, marked in hundreds of feet. The estimated depth of this MH is 6 feet. The steel pipe is sitting on gravel on a cement foundation and ground water from the surrounding area can infiltrate. **ACTIVE.**

Mh 6A. Two foot diameter green plastic cap.

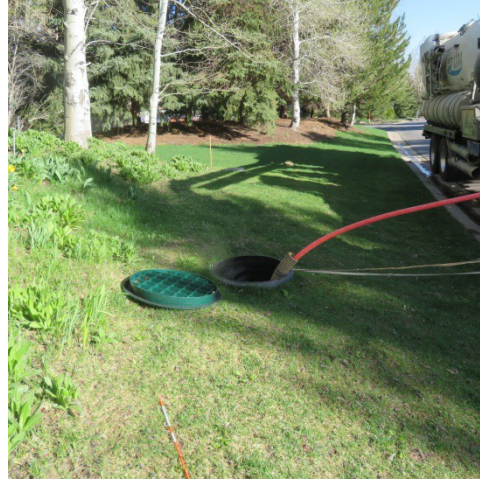
Mh 6A Pro-Pipe clean-out through to Willow Creek.

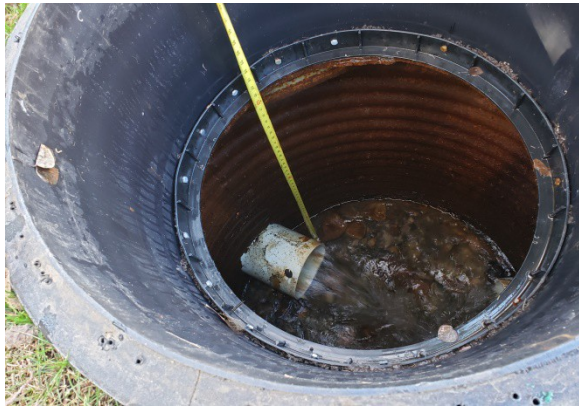
Mh 6A view of interior of steel conduit and white solid PVC outlet pipe. Inflow and outflow in direct oppositional sides. Water depth in conduit is less than six inches. April 4, 2020 inspection.

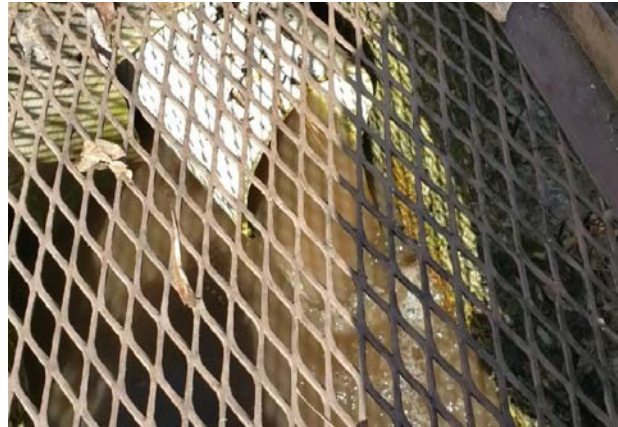
Segment A's only discharge drain; via Mh 6A outlet through solid PVC discharge pipe in easterly direction, under E. Meadows Drive, between Lot 105 & 106, into Willow Creek. This drain is the only place where the UD water reaches full Daylight.

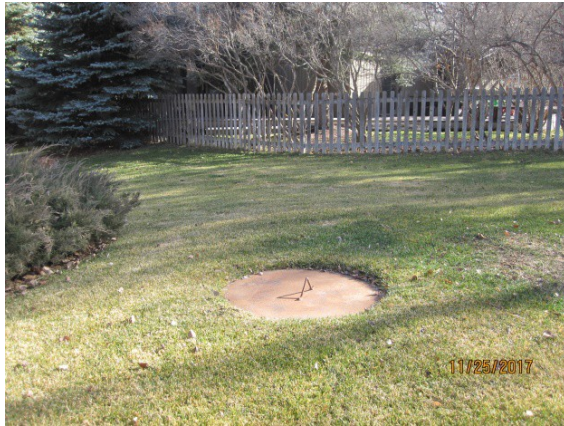
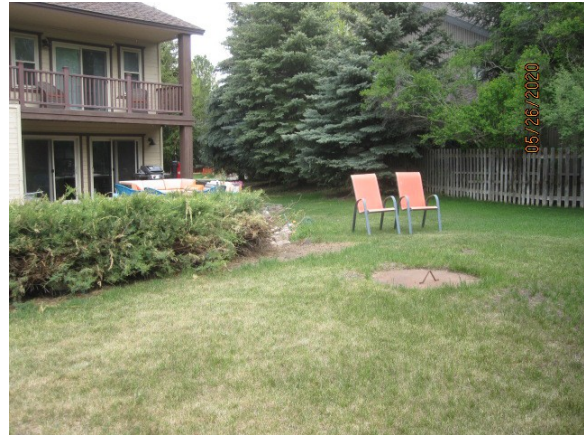
Mh 7A on Lot 88, 4911 East Meadows Drive. Fischer. In Nov. 25, 2014 Alliance Engineering: "The Steel lid is exposed in backyard. Easy to find, at grade." Here are two photos of the large drain cover on Lot 88 near backyard patio, 2017 and 2020. Inflow via perforated tubes 6' to 10' underground, all were installed on 94 private homeowners properties.

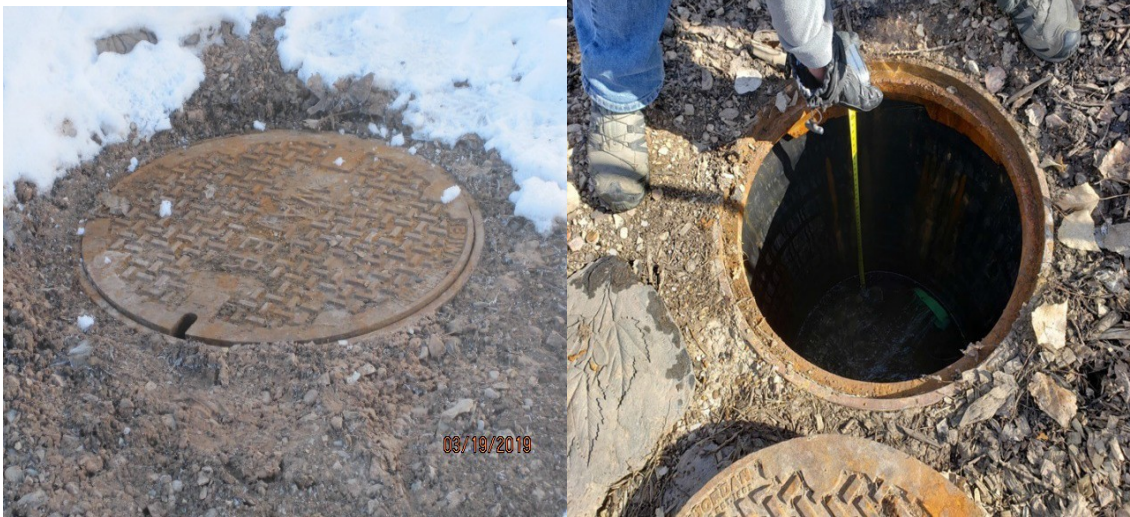
Mh 8A This Mh was added c2017 at Lot 68 Willow Loop near the curb. Lachowitz. It has a 2 foot opening with a steel cover. The water at this Mh was flowing lightly and was at a low level at the inlet and outlet pipes. The inlet to this Mh is from Mh 10A Lot 54. The outlet is into Mh 7A. The ProPipe person operated the Water Jet clearing hose into the inlet and outlet pipes in the Mh. There were a few roots coming out of the inlet pipe into the Mh 8A. There is a great deal of damage to the front yard, now covered with chipped pine bark. **ACTIVE.**

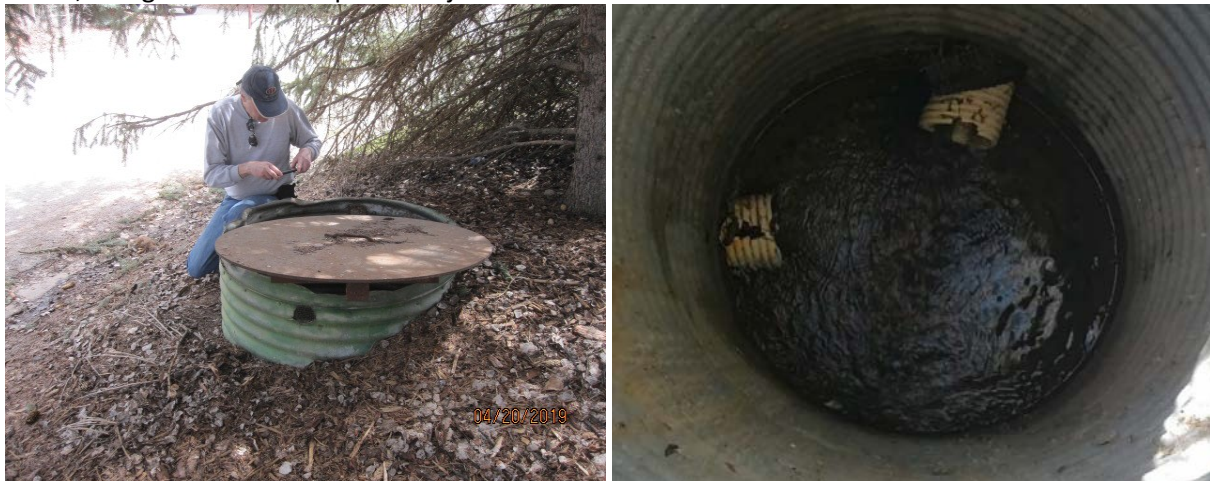
Mh 9A Lot 70. Jon Ball. On Willow Loop. Four foot lid cover and green steel conduit above grade, located 5.3 feet behind the gutter. This mh has a 4 foot opening. The water at this mh was flowing lightly and was at a low level at the inlet and outlet pipes. The inlet is from Mh 16A. Outlet is to Mh 7A, then on to Mh 6A. The ProPipe person operated the Water Jet clearing hose into the inlets and outlets pipes in the Mh. The inlet (and outlet corrugated pipes) into Mh 9A is damaged, how and why is not known. The suspect is the ProPipe jet hose and nozzle, along with the 2000 psi water jet. **ACTIVE.**

Clay measuring height of water in steel conduit. Height of water less than 6". Damage to tubes.

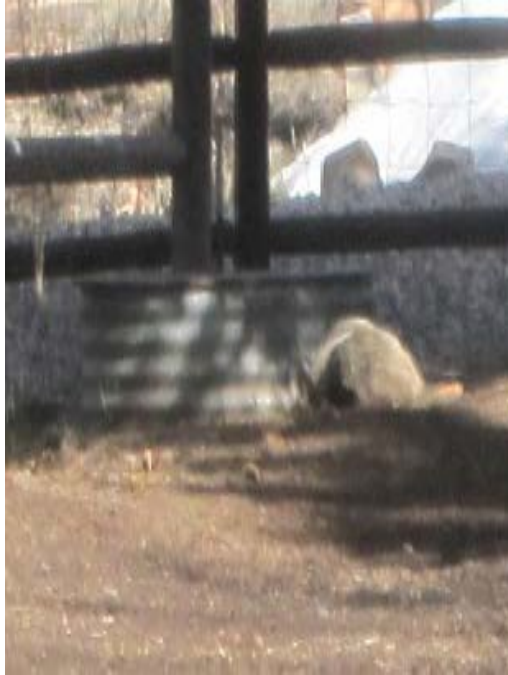
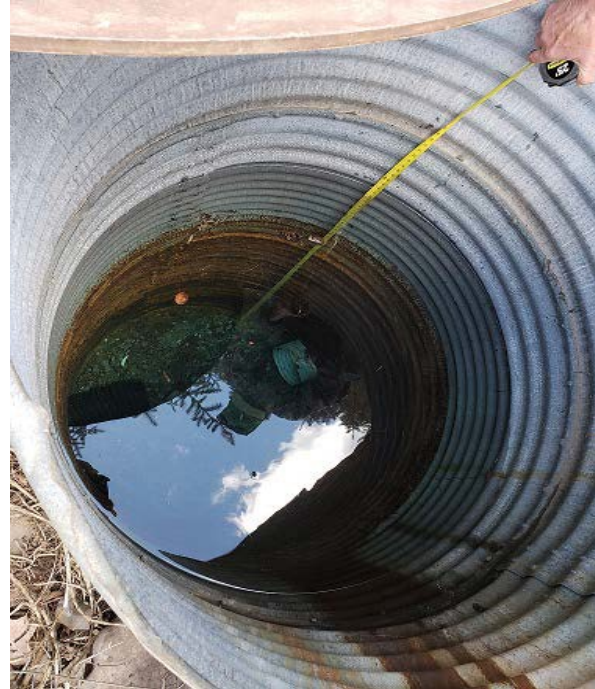
Mh 10A Another above grade MH conduit, has a 4 foot opening with a steel cover. The Mh is at the east end of the back yard of Kautz Lot 54, approx. 170 ft. behind its curb on Silver Springs Road. The water in this Mh was flowing lightly [dropped approx. 60" from the April 4, 2020 inspection of 82"] and was at a low level at the inlet and outlet pipes. A low level surprise for this time of year. The inlet to this MH is from MH 11A is minimal. Outlet is into MH 8A. The ProPipe water jet was not used at this location.

This conduit is subject to, without overflow, water level fluctuation in the Spring, for this reason we designate it as ACTIVE.

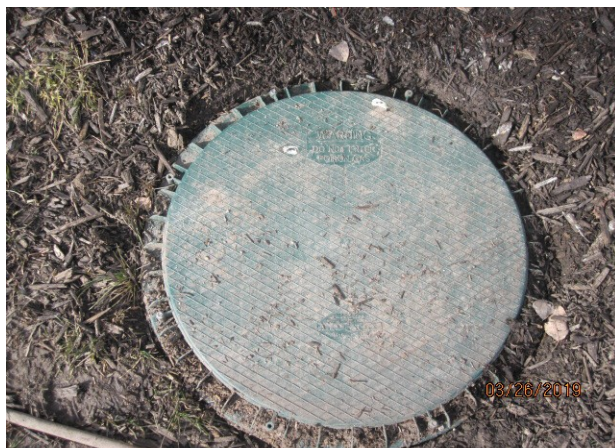
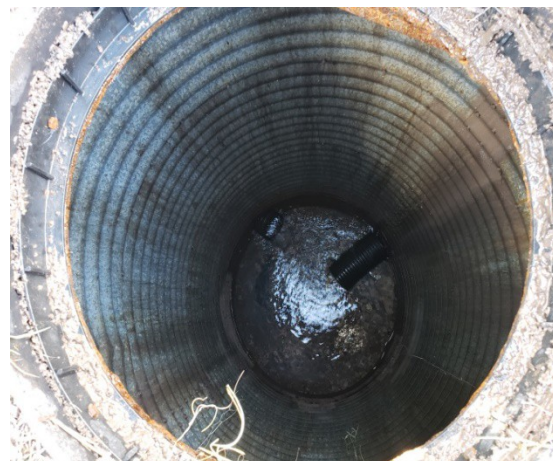
Mh 11A on Lot 25, Paulus, Meadows Connection. This Mh has a recent 2 foot opening with a green plastic cover. The water at this Mh was flowing lightly and was at a low level at the inlet and outlet pipes. The inlet to this mh is from mh 12A an buried manhole on Lot 22. Alliance Engineering: "Found steel lid in a low spot in the landscape area below grass cover. 8.5' behind curb/gutter; sewer mh 22.1 feet; from mailbox 43.9 feet. Low level activity manhole. Recommend not to clean out this Mh. Intervals minimum of five year inspections. If clogging builds up it will be a benefit to the problem areas, Mh 8A, 9A. **Inactive.**"

During inspections there is very little water activity, less than 6", less than half the diameter of the tubes.

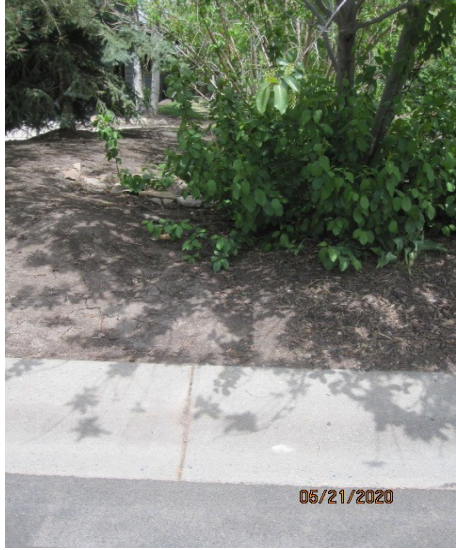
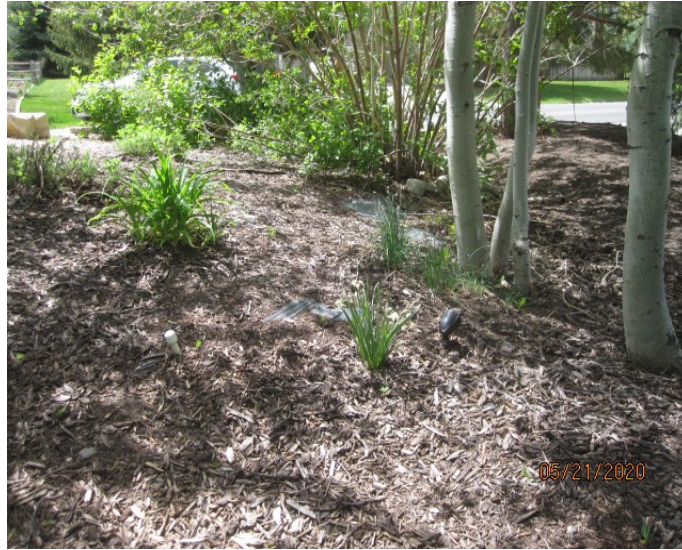
Mh 12A Lot 22. Jenson on Meadows Connection. Alliance Engineering: "Found steel lid in landscape area 22+ inches from curb. 8.5 feet behind curb/gutter. 20.7 feet from mailbox. 3 feet to electric box." Buried beneath a berm. **Inactive.**

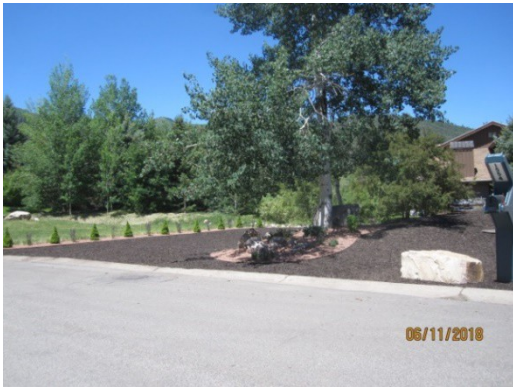
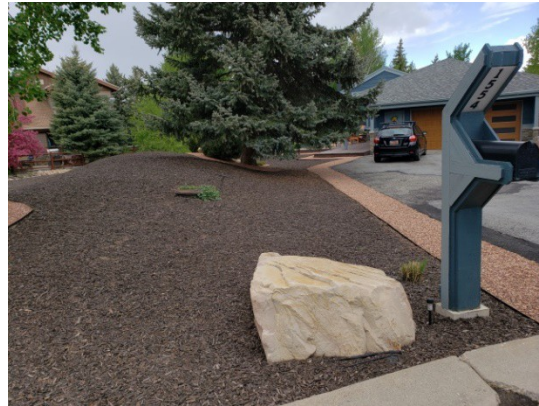
Mh 13A Lot 17 Mehregan on Meadows Connection, an upper elevation lot. Next to Parcel "V" and Water Channel "Q". Alliance Engineering: "Did not find manhole. Found buried t-post.... 7.6 ft. from curb/ gutter; 19.6 feet from mailbox." Buried and **Inactive.**

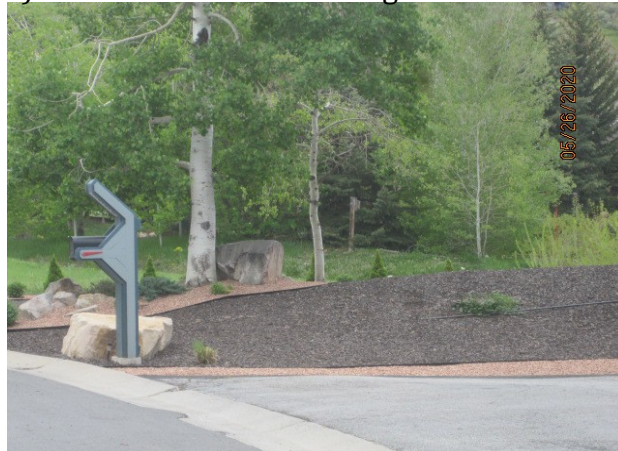
Parcel "V" on left (west) side of small conical evergreens.

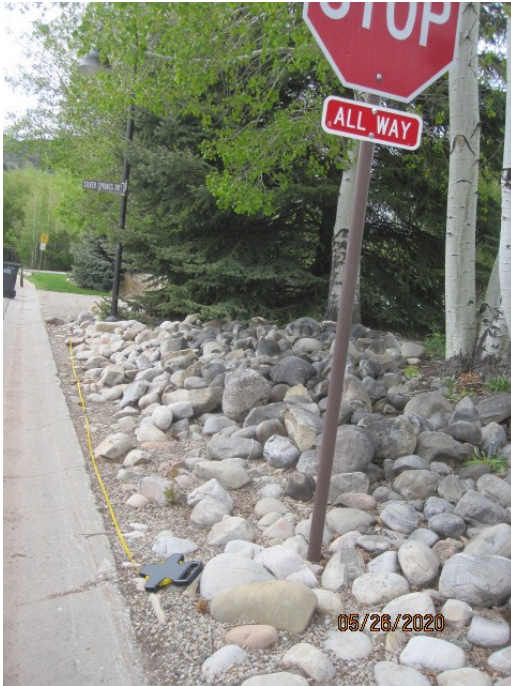
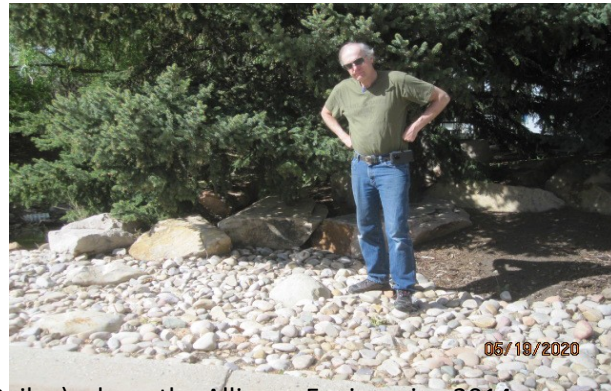
Mh 14A West of water channel Parcel Q; at intersection of Silver Springs Drive and Silver Springs Road, along the south curb area of the Master Association Park property. Alliance Engineering: "Found steel lid in landscape rocks at 12 inch depth, East 26.1 feet from street signs and stop sign; five feet behind curb/ gutter; 39' from sewer Mh" . Either Alliance Engineering made a description error on their 2014 UD report or they made an error on the map placement of the Mh 14A location. In either case 14A is Inactive. The Master Association has added additional landscape rocks on the area shown on the left side photo.

Photo above right shows easement at Lot 37 (Bailey) where the Alliance Engineering 2014 map and former UD Committee members report is the Mh14A location. Buried and **Inactive**.

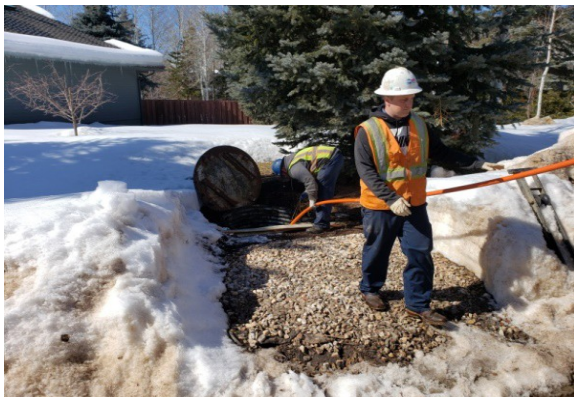
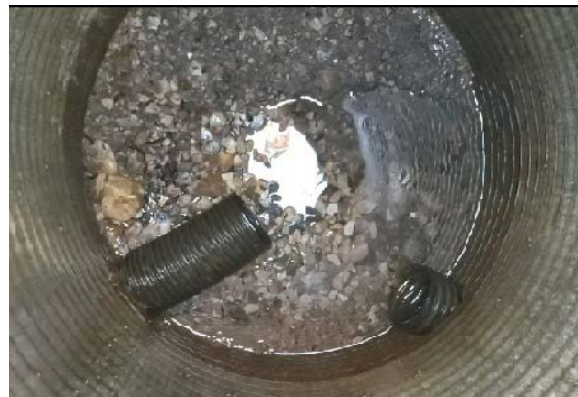
Mh 15A Lot 39. Heinz. Green steel lid exposed in 2014. Landscape bark covers the lid, and usually a round stone above center of lid; west of spruce tree, 11' up from the curb. The outlet to this MH is east, downhill to MH 16A (Silver Springs Road near Lake Front Ct.), then to mh9A, on down. In the west direction, Mh 14A resides at the street sign at the Park. The A.E.'s UD map and location description are different. It is unlikely the UD line traverses under the Parcel Q water channel. UD's reducing water flow is suspected of creating property damage to lots 38 & 39 as it takes away the ground water needed by the mature trees. The dribble of water flowing through mh15A is under 6" height, little reason for an annual inspection and clean-out. The troubled central SSSF Mhs 6A, 8A, 9A, and 10A would benefit by restricting flow from Mh 15A. We recommend not to clean out this Mh, inspections at five year intervals subject to drought conditions. There is evidence Pro-Pipe has damaged the plastic tubes in this and other Mhs by the use of their nozzles, hoses, and cameras.

Pro-Pipe inspecting Mh 15A. Clogged is good news. Interior of conduit shows low water level input & outlet.

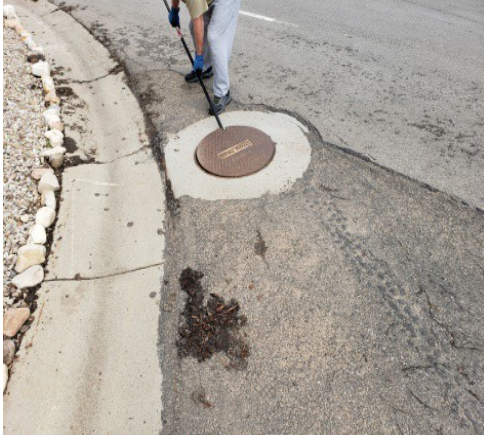
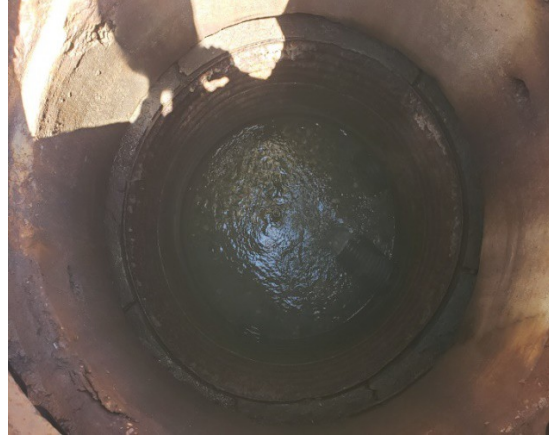
Mh 16A This MH has a 2 foot opening with a steel cover marked "Storm Drain" located near curb of Lot 49, Rand Howard, near the street corner of Lake Front Ct and Silver Springs Road. The water at this MH was flowing lightly and was at a low level at the inlet and outlet pipes. The inlets to this MH are from MH 15A and 17A. The outlet is into MH 9A. The ProPipe person operated the Water Jet clearing hose into the inlet and outlet pipes in the MH. The ProPipe person when operating the Water Jet in the inlet pipe from MH17A thought he was running into a blockage, but then realized he was trying to go uphill to MH17A on Lake Front Court, that was what was creating the appearance of a blockage. Issues at Lot 42 from 2005 to 2007 were mitigated and holding. Increased drought over the years has diminished flow. **LOWACTIVITY.**

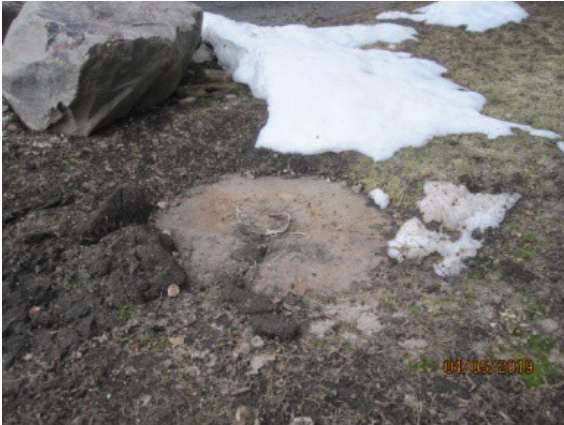
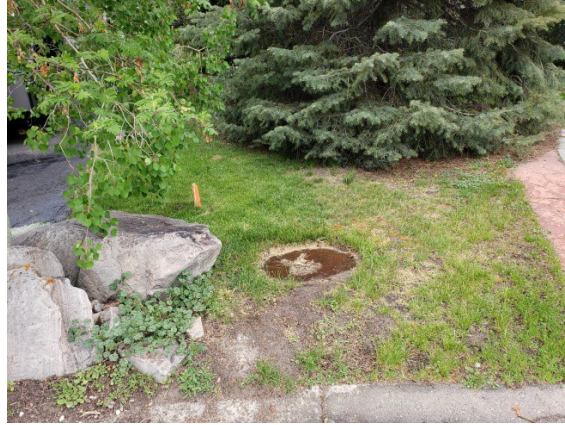
Mh 17A Located at Lot 48, Groth. Lake Front Court. Steel lid exposed at grade. West side of driveway, near curb, next to large flat boulders. Lid has a metal ring on the top center. Rarely inspected. **Inactive.**
